Water Main Break Update

Operations Committee

April 5, 2024

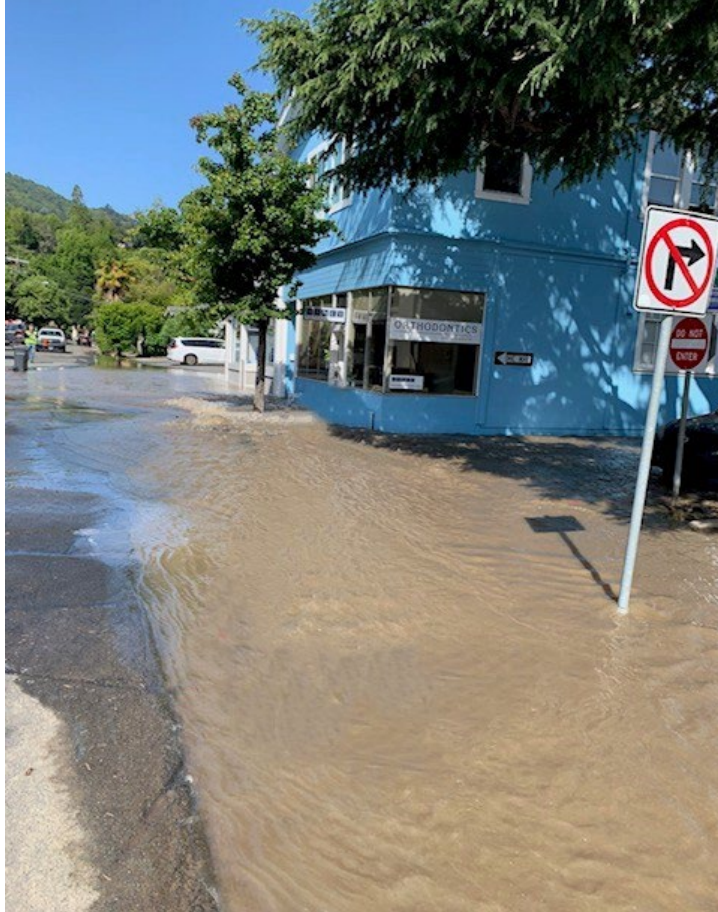
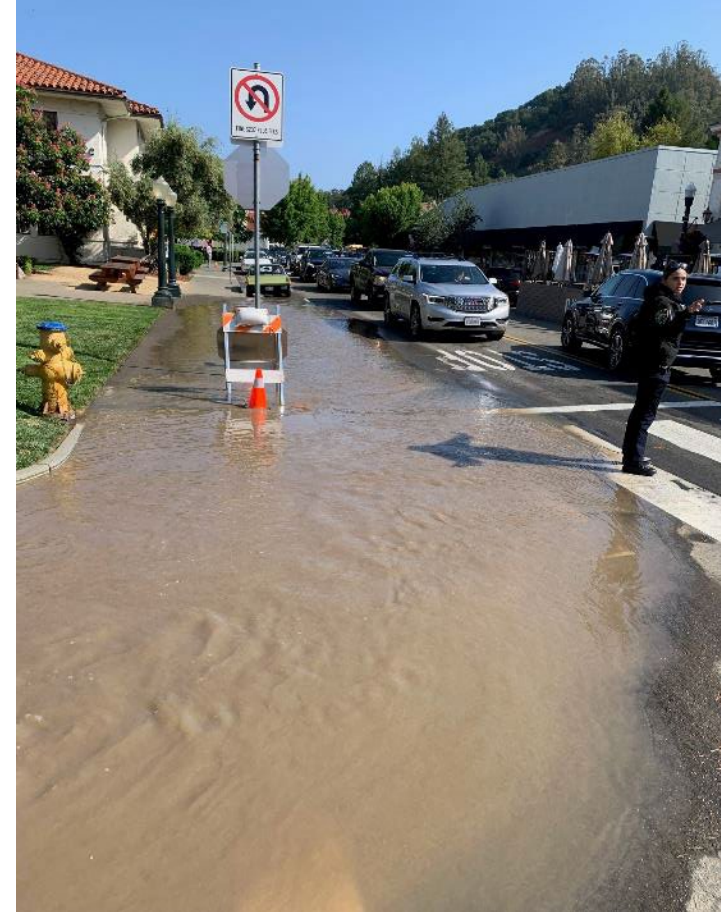
Class I Water Leak

Tunstead Ave, San Anselmo – June 2023

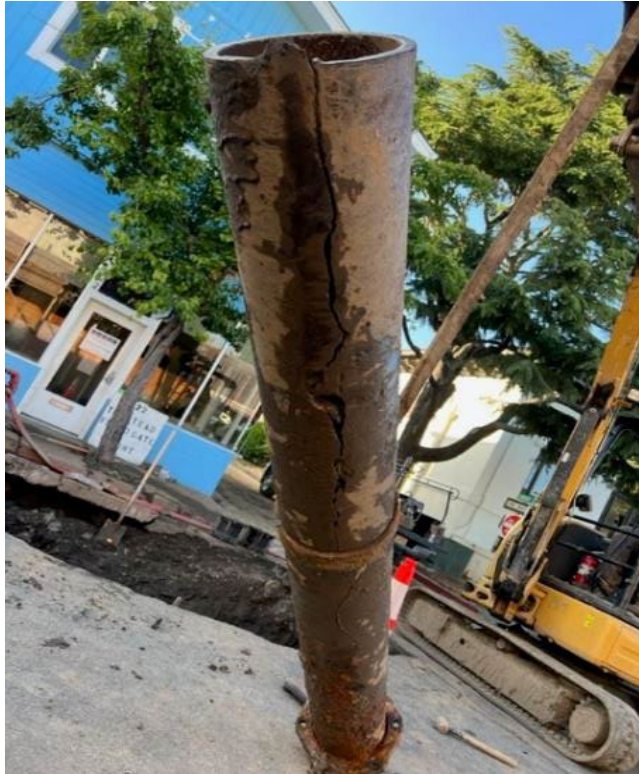
Broken 8 inch cast iron water main

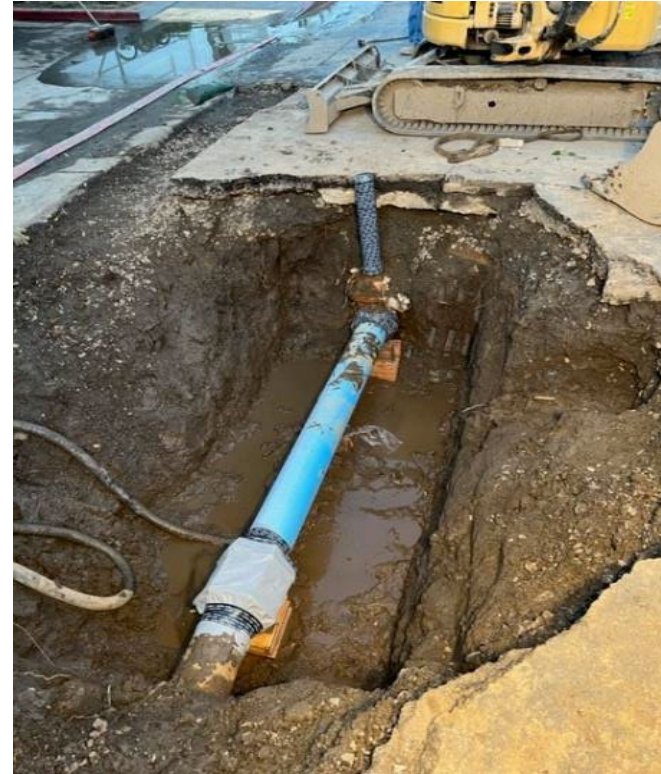
Repaired 8 inch water main

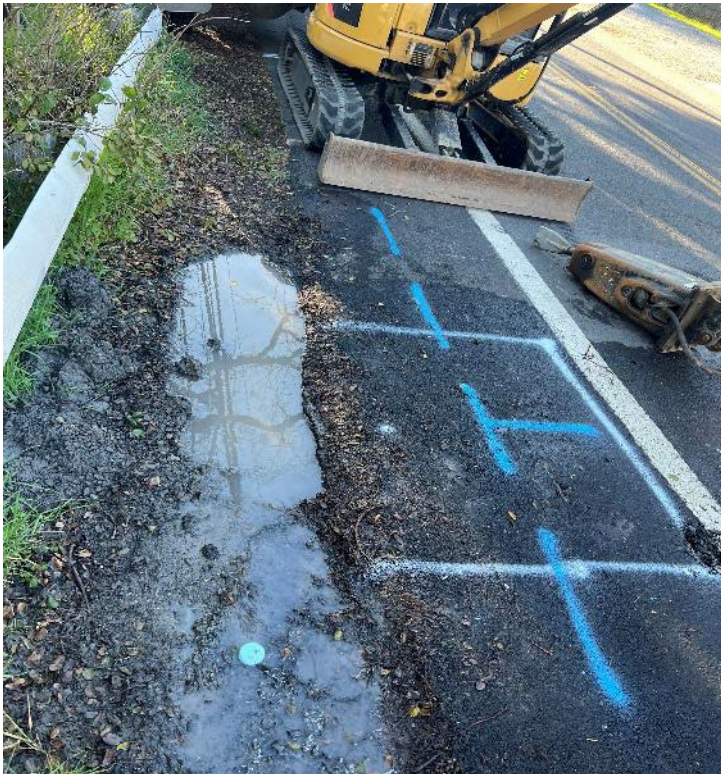
Visible water leak

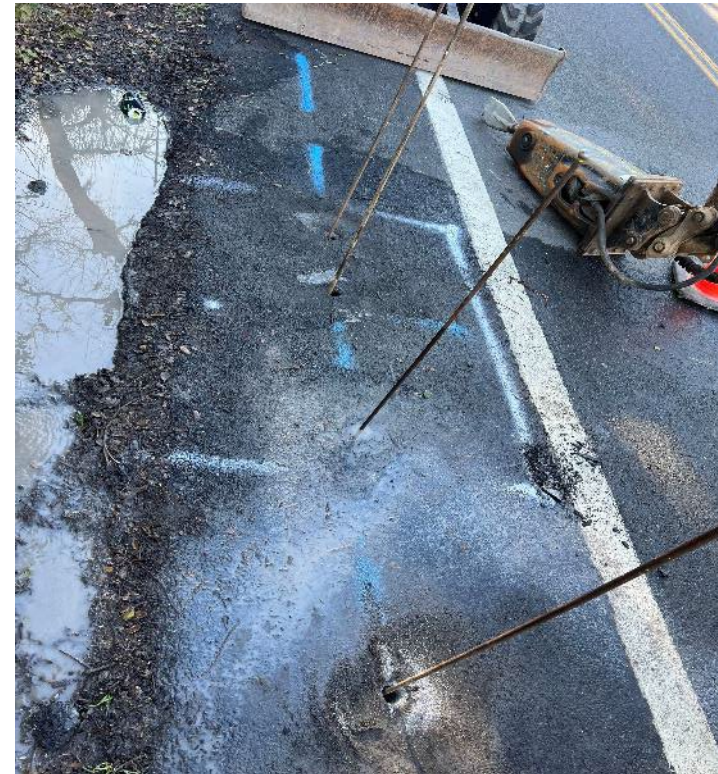
Test holes locating leak location

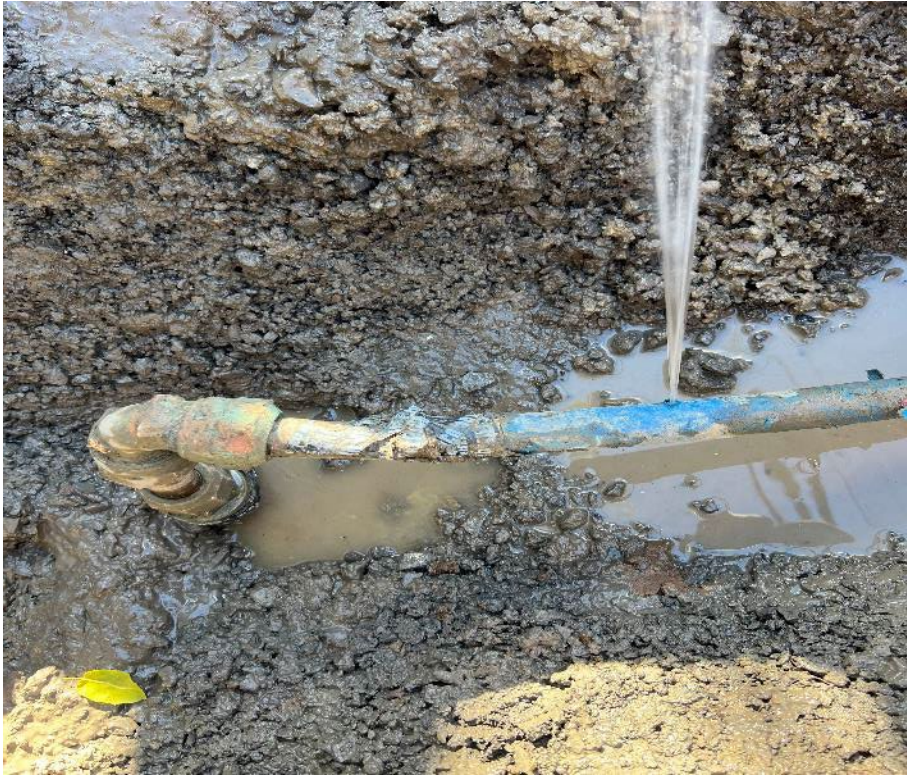
1 inch copper leak

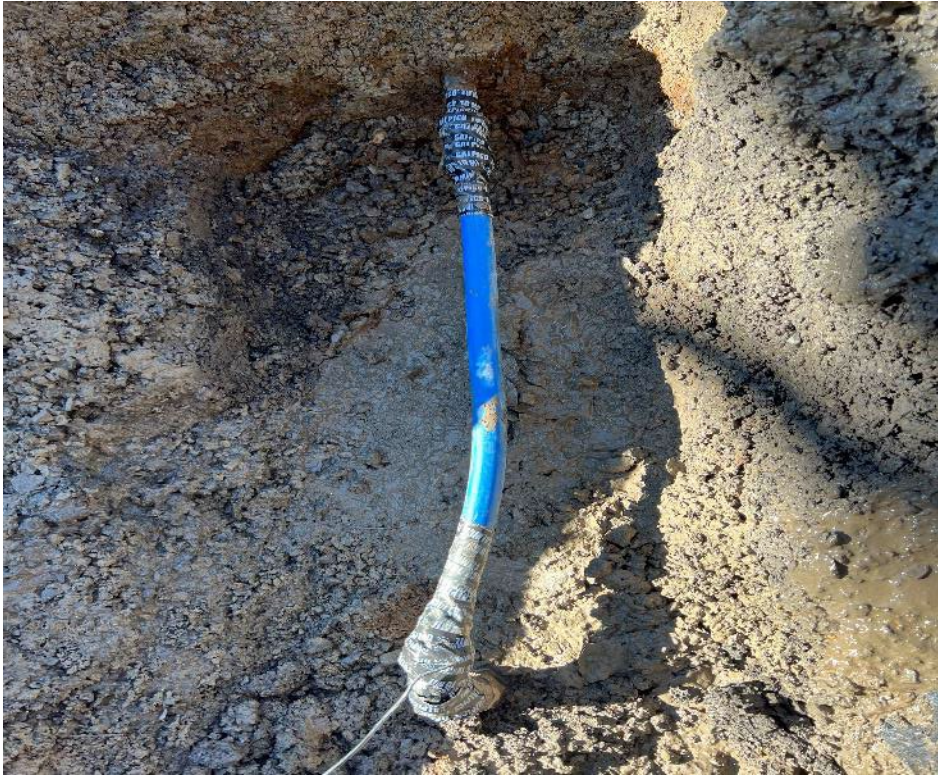
Repaired 1 inch copper

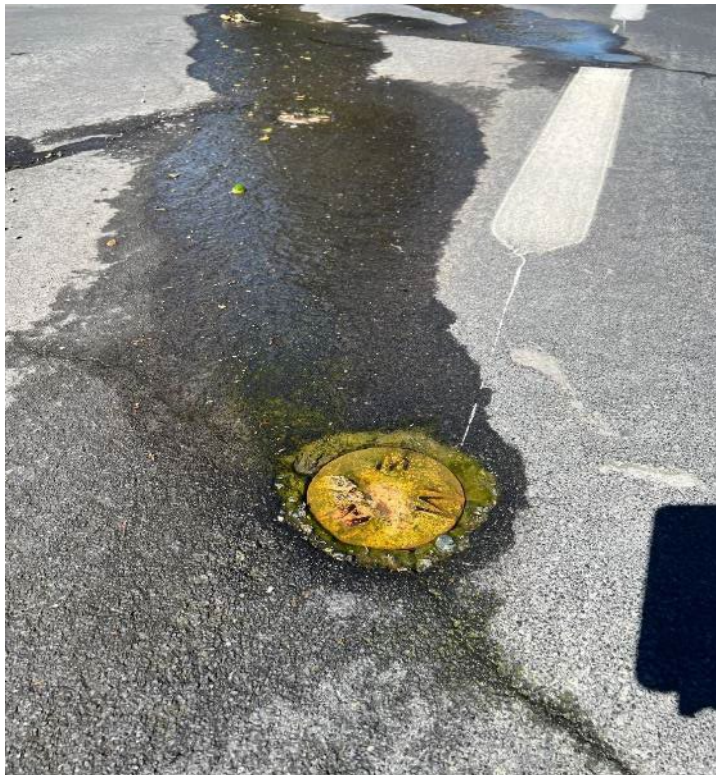
Visible water leak at valve

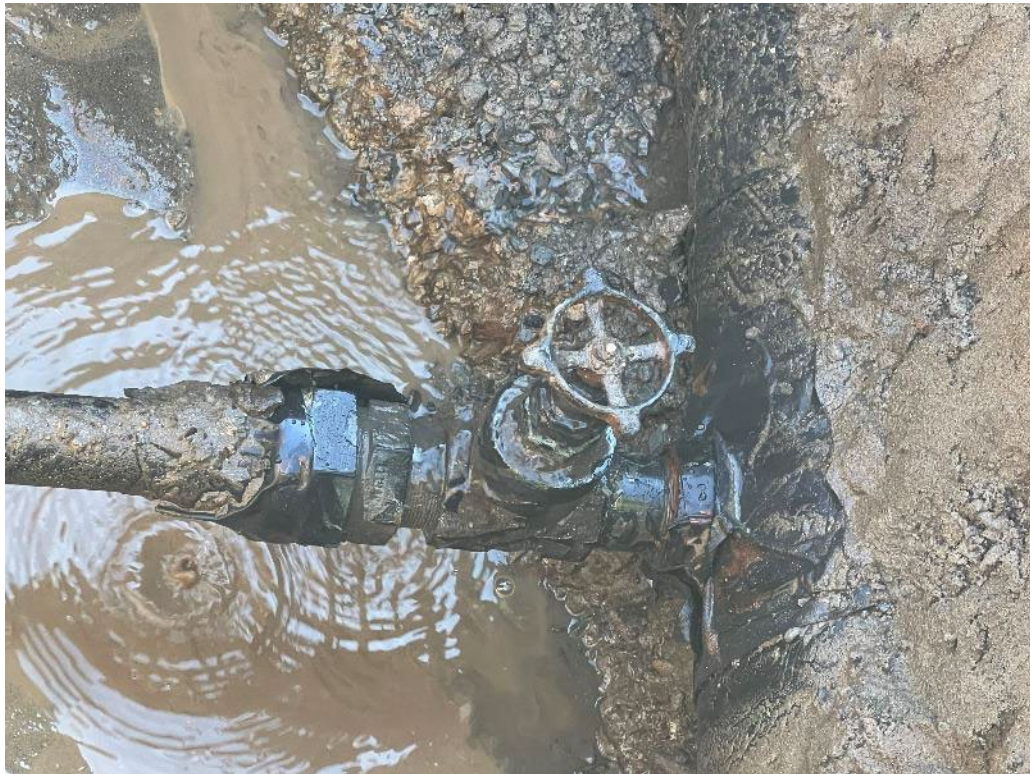
Leaking 2 inch gate valve

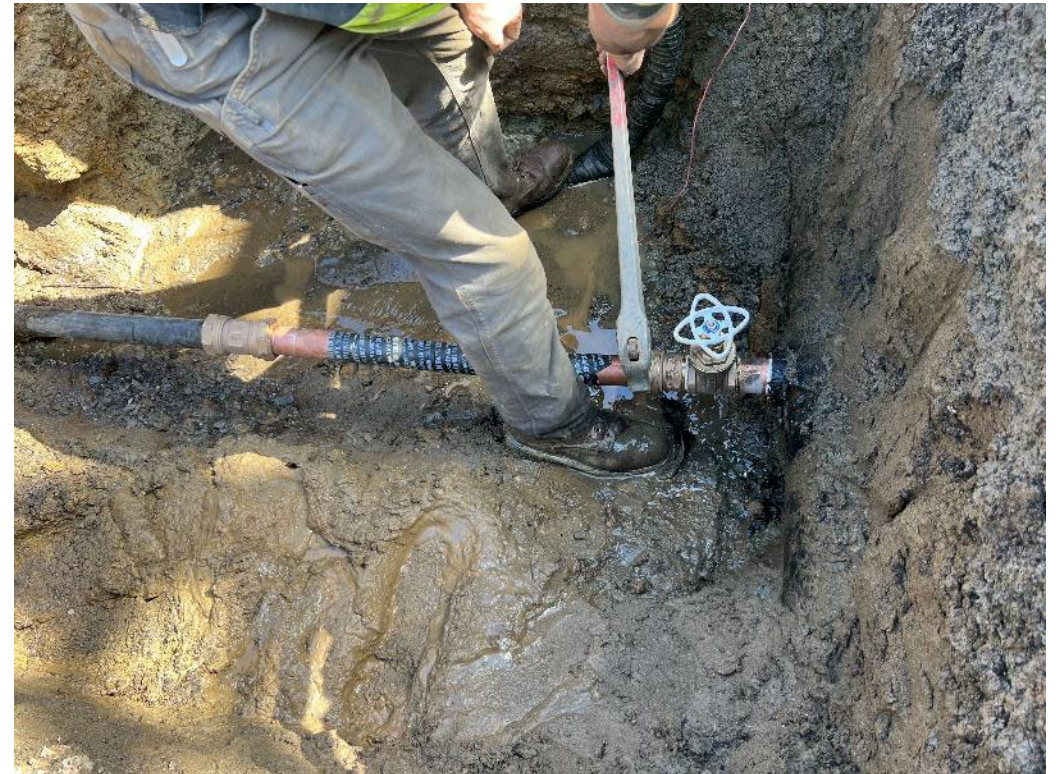
New 2 inch gate valve

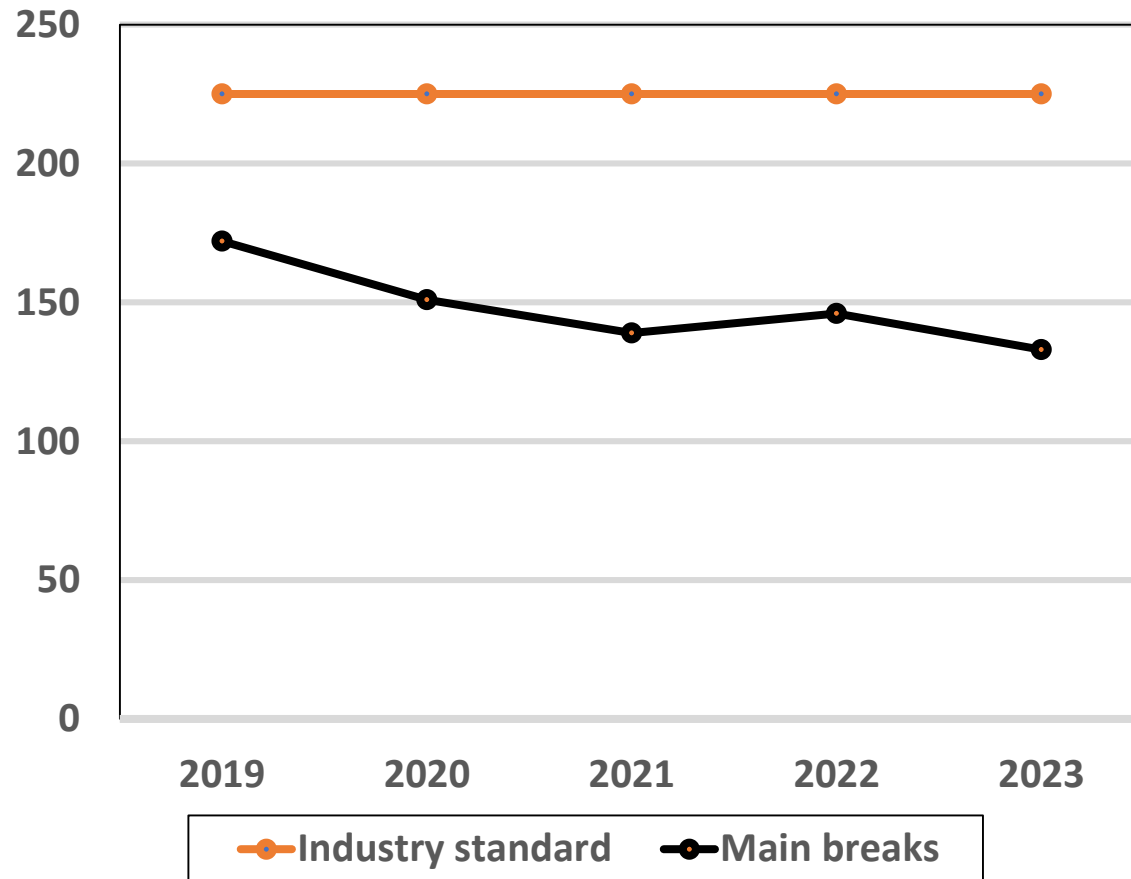
Water Main Leaks Compared To Industry Average

■ **AWWA industry average** -----

- 25 water main breaks per 100 miles of pipe per year (12 month period)
- 900 miles of pipe = 225 main breaks per year

■ **Water main breaks** -----

- 2019 total = 172
- 2020 total = 151
- 2021 total = 139
- 2022 total = 146
- 2023 total = 133
